# *Burnt Clay Products in Fire and Earthquake*

*Issued by the Manufacturers of Burnt Clay Products*  
***Brick Construction Association***  
*707 Lankershim Building, Los Angeles, Cal.*

## *The San Francisco Calamity*

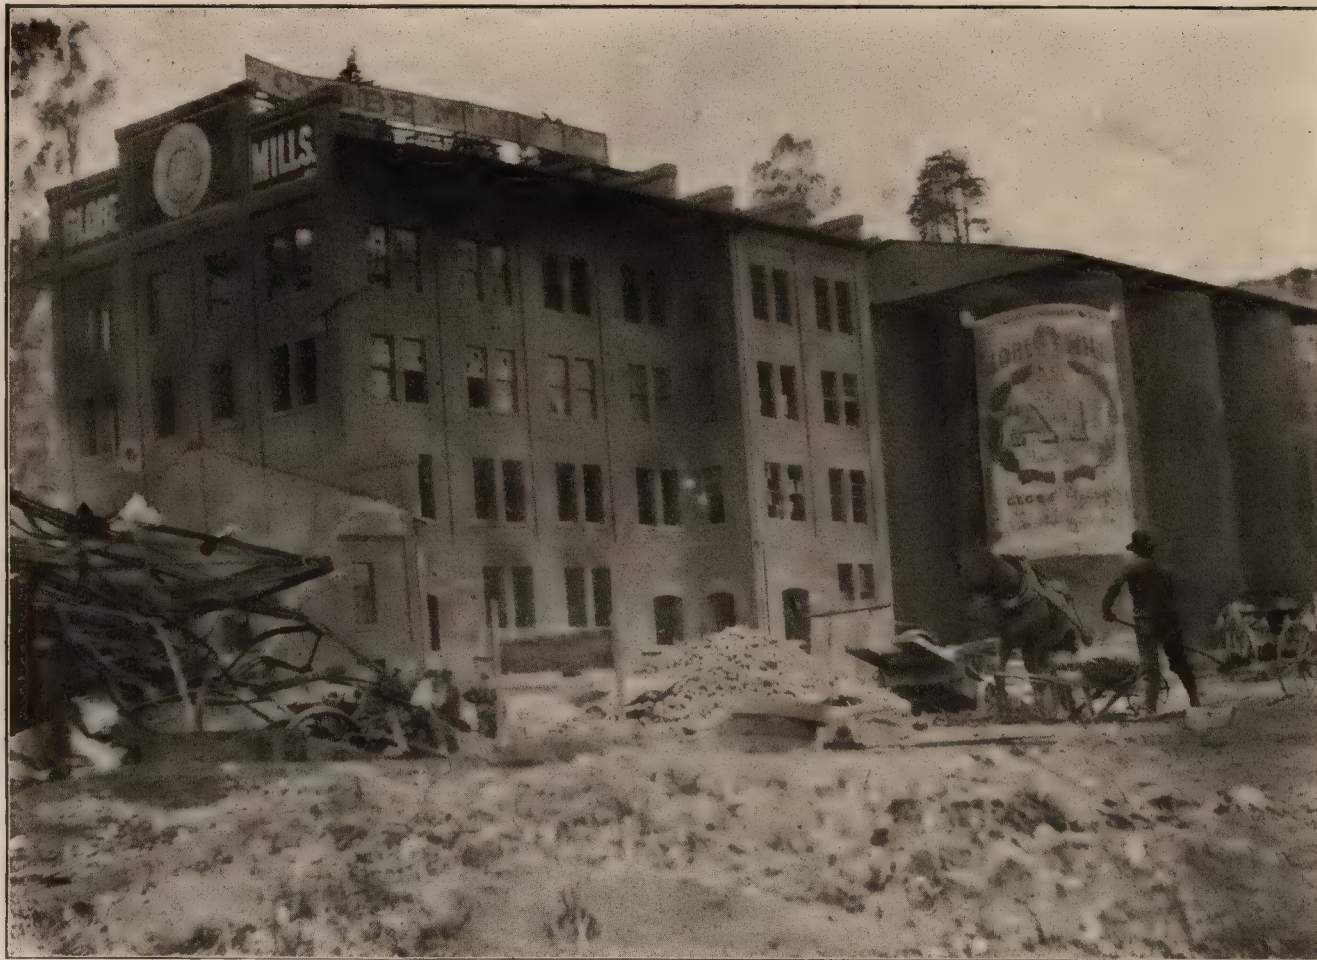
*Globe Mills after Fire and Earthquake*

The building here shown is the main building of the Globe Mills, and is of all brick construction. Note its excellent condition, also pile of twisted iron and collapsed concrete annex in the left-hand corner.

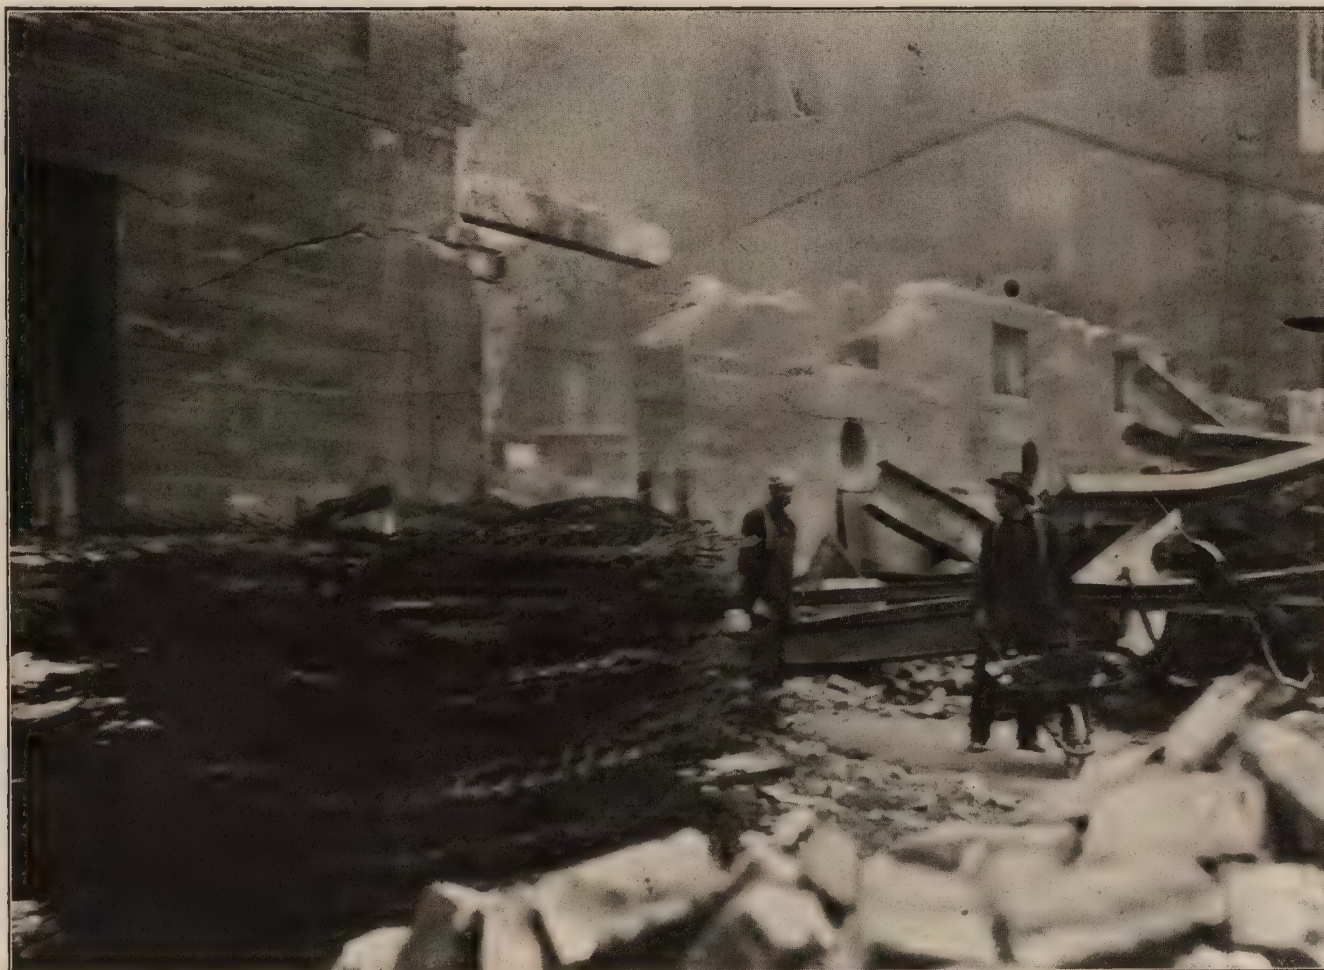
*Globe Mills, Concrete Annex, Total Collapse*

This was an addition to brick building, concrete side walls and reinforced concrete floors and roof. Note breaking points in the concrete wall.

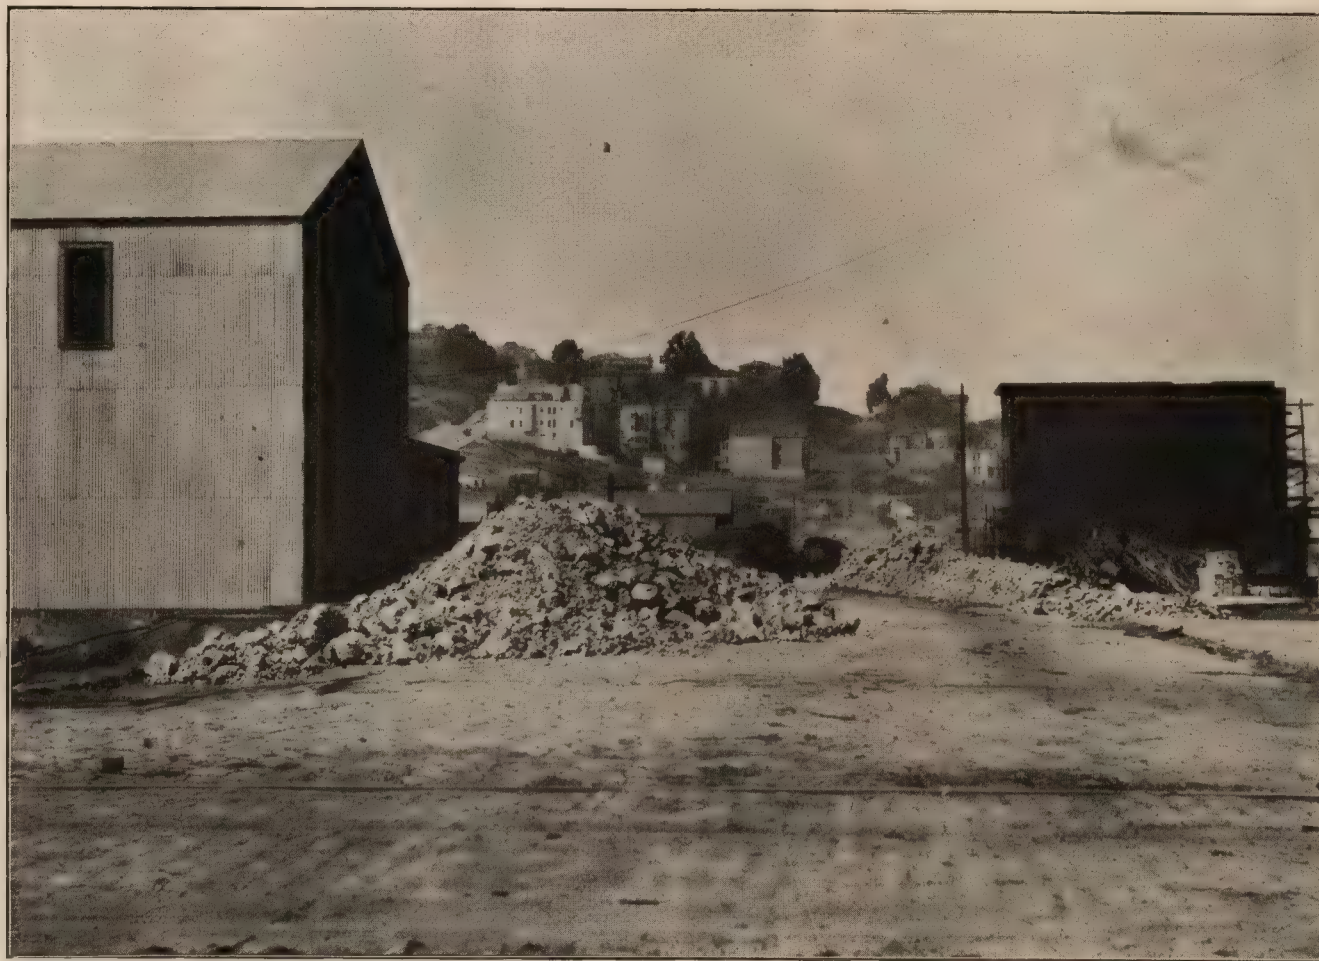
*Concrete*

That had been removed from destroyed building on Francisco street, between Powell and Mason: Next picture shows camera at closer range.

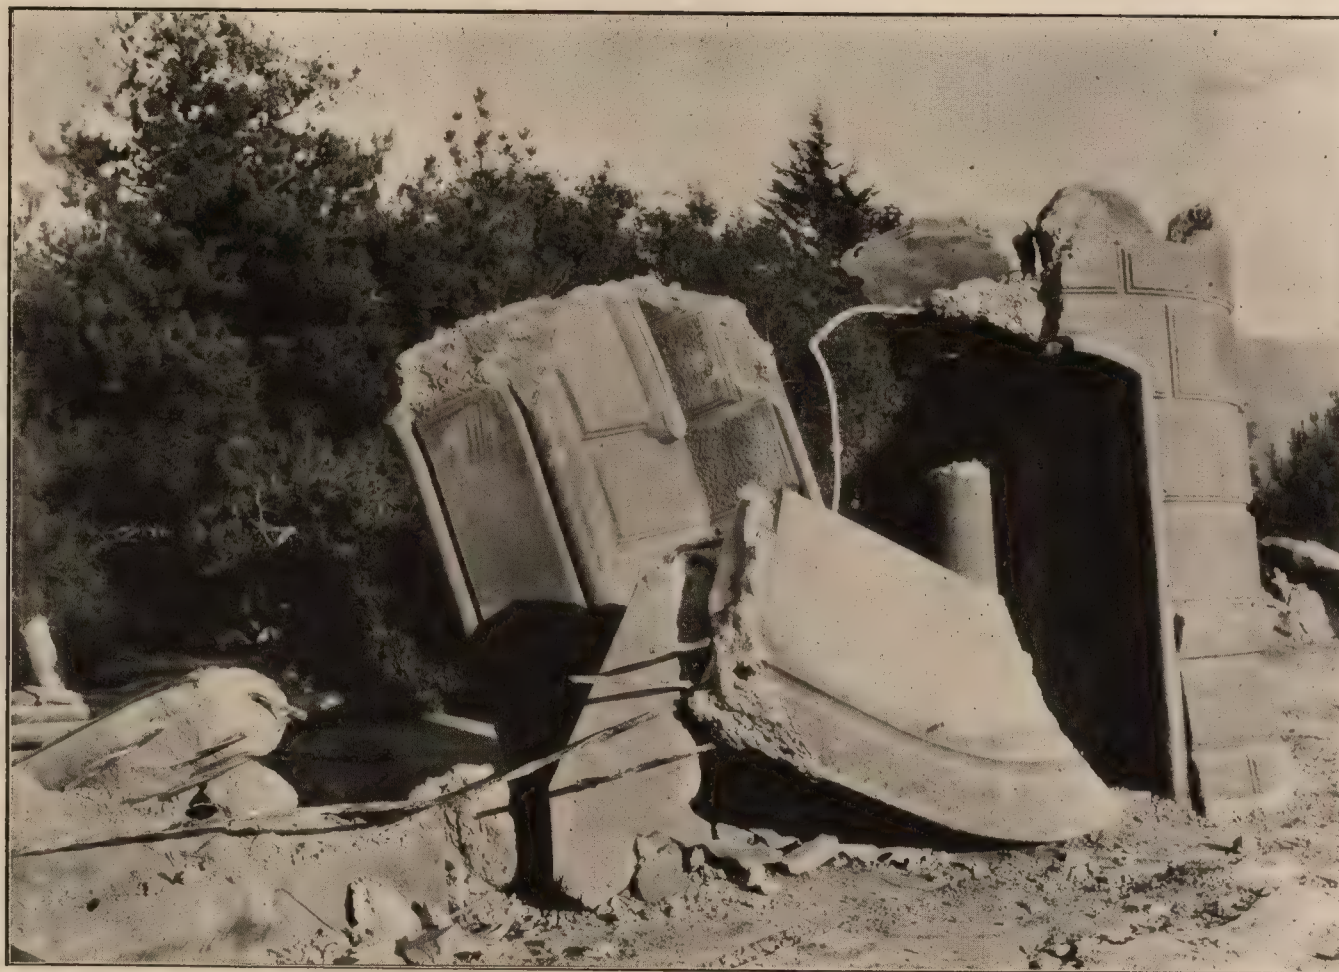
### *Concrete Observatory*

Another view at close range, showing the system of reinforcement. This collapse was due wholly to earthquake.

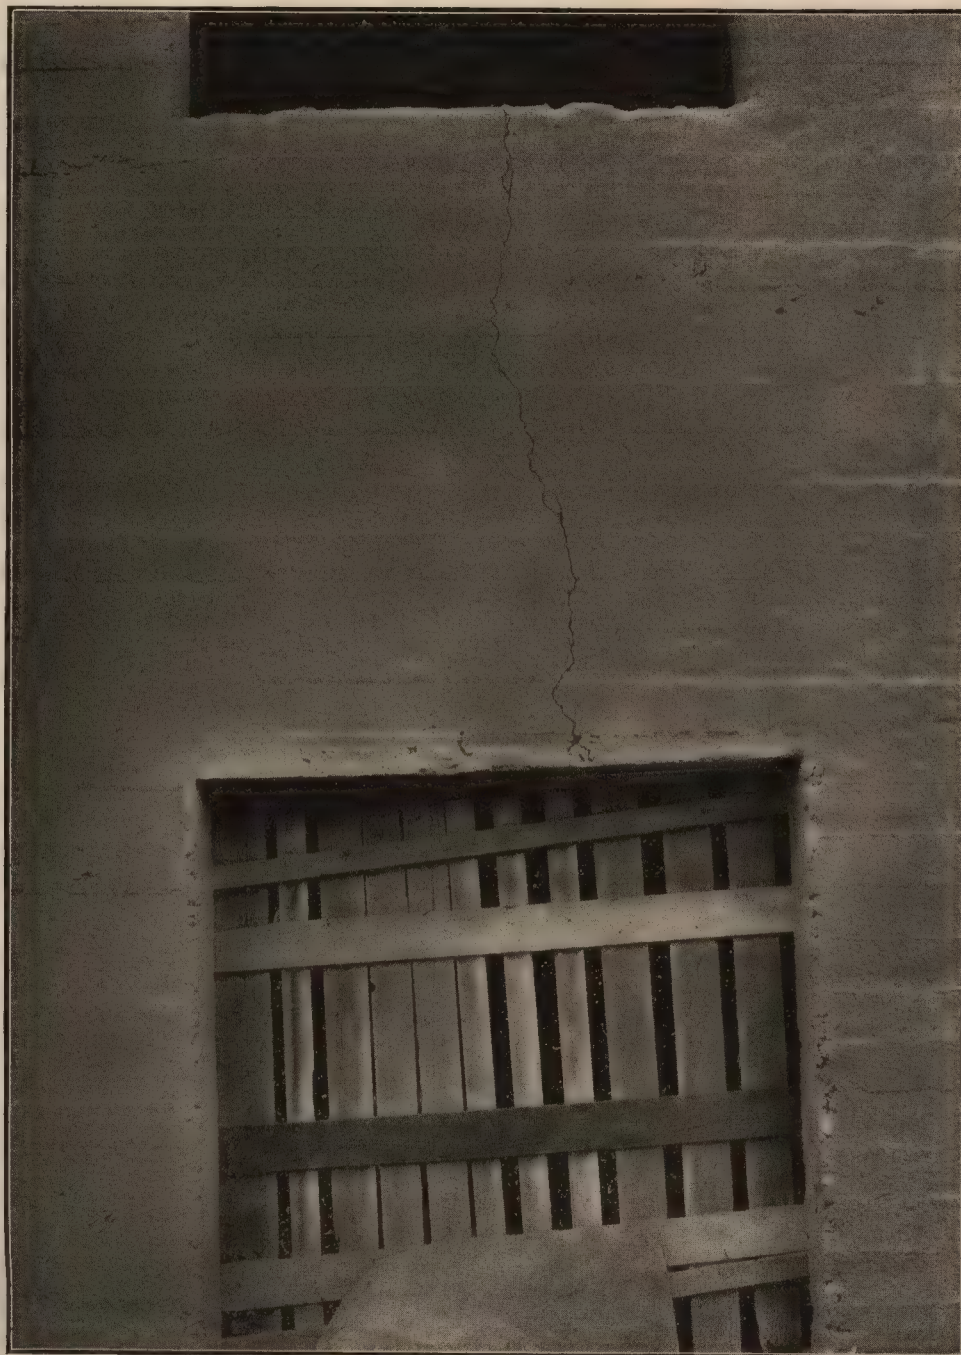
*Fairmont Hotel, Monolithic  
Foundation*

Earthquake cracks in the concrete wall appeared every few feet in the length of the building. The cracks started at the bottom and extended up to the line of the brickwork, where they stopped. This wall was more than 30 inches thick, and made from an excellent quality of cement and broken rock.

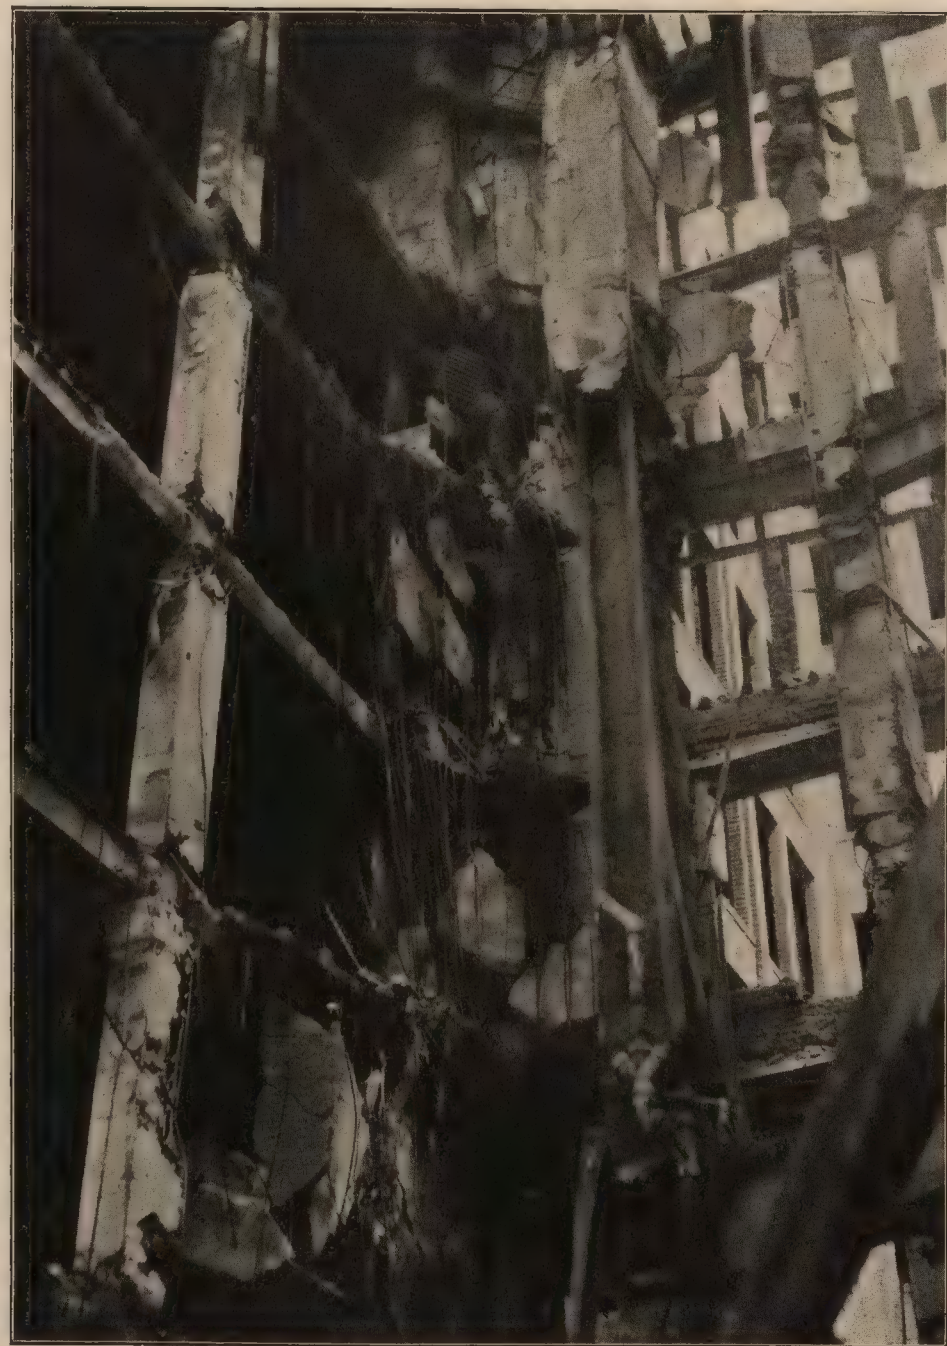
*Reinforced Concrete Floors and  
Concrete Fireproofing*

Did it stand the test?  
(Total wreck.)

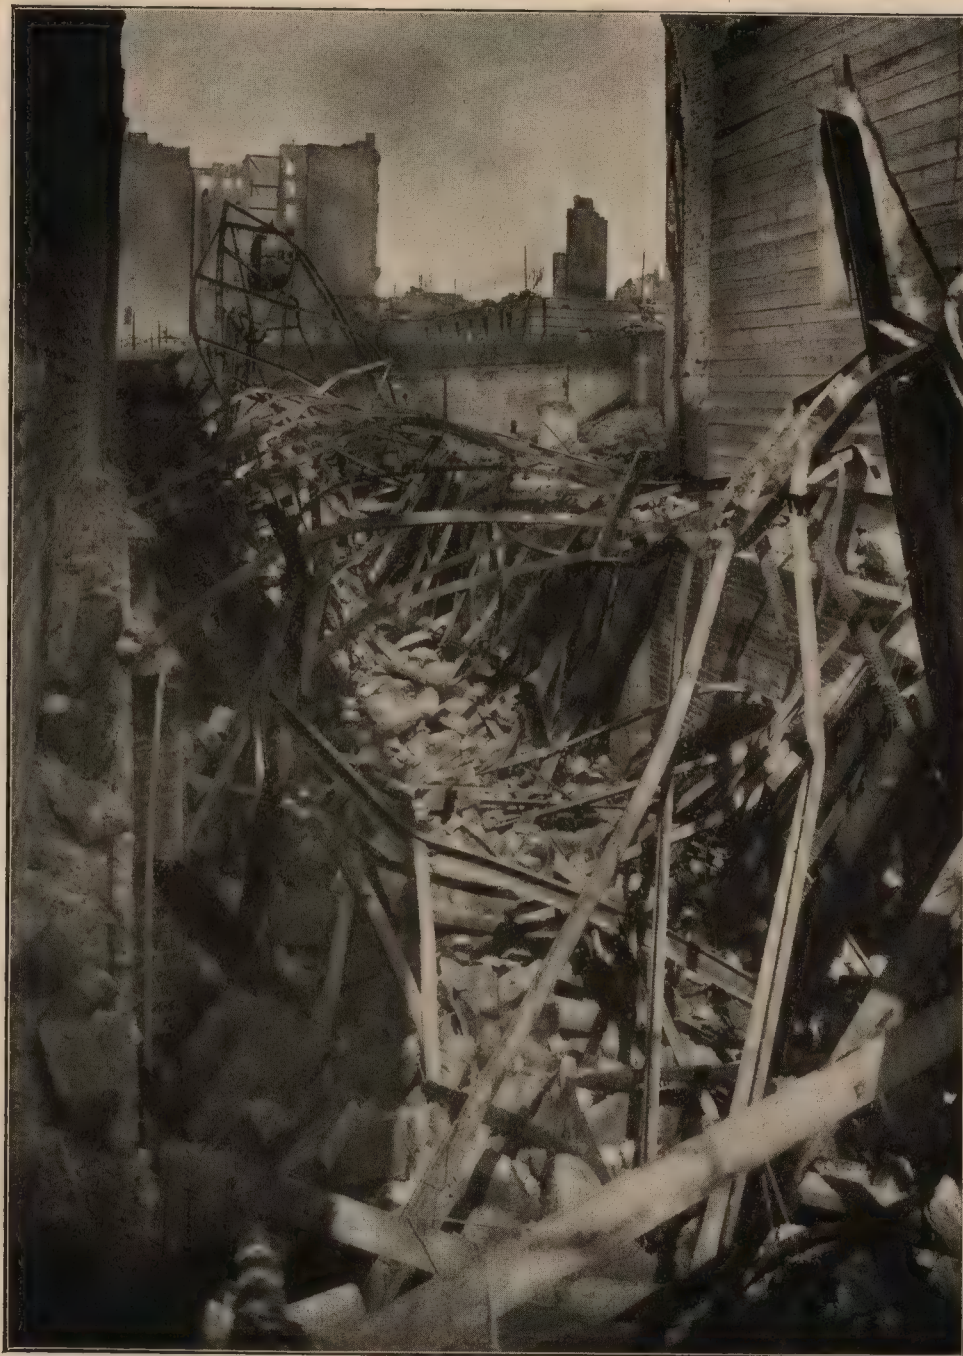
*Reinforced Concrete Building at  
Powell and Sutter Streets*

Showing effect of fire. Was once the pride  
of the owner and architect.

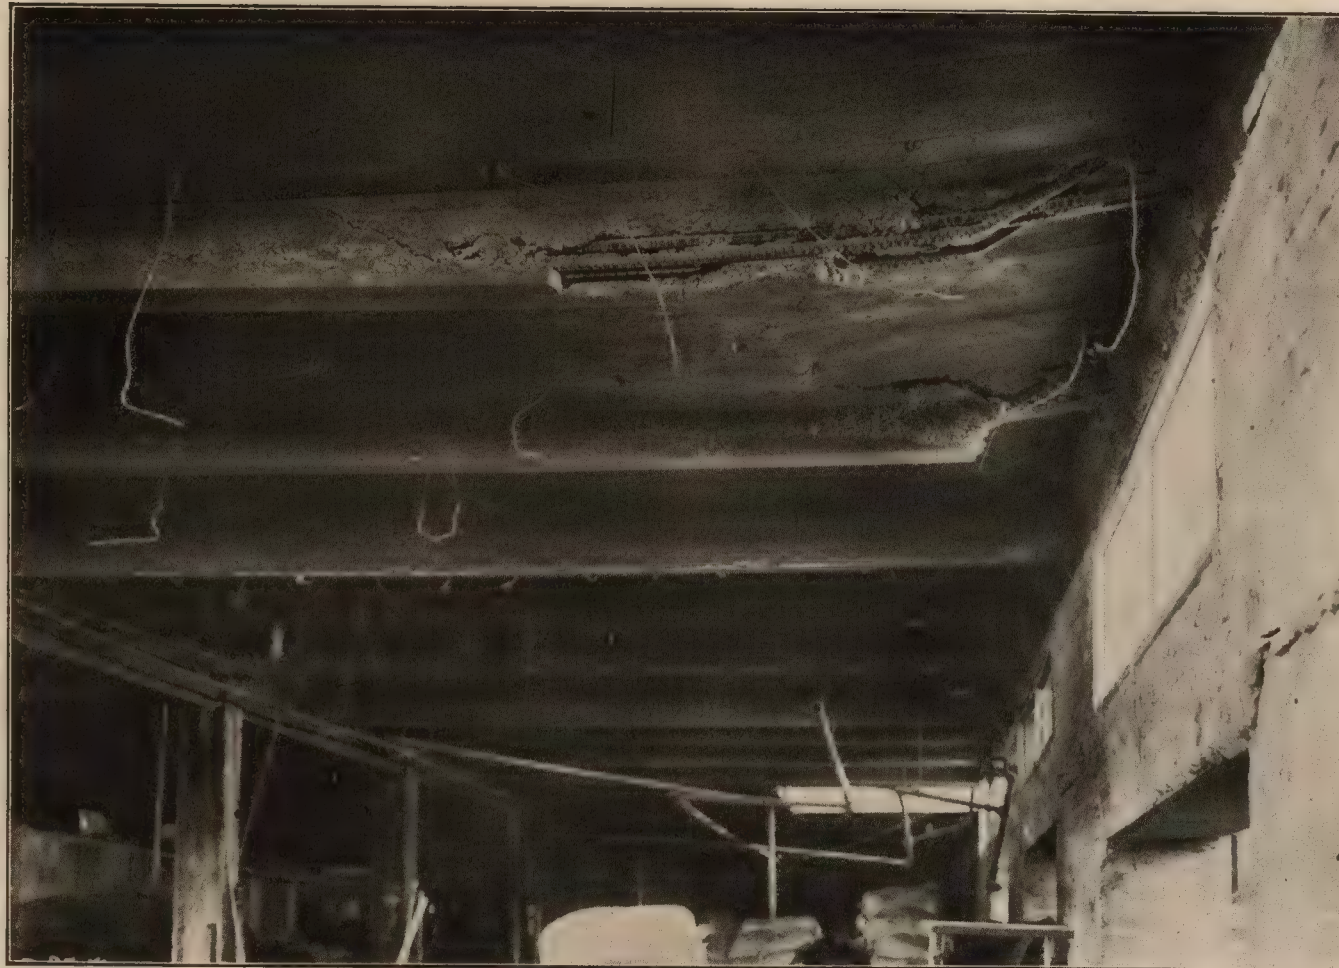
### *Monadnock Building*

Reinforced concrete beams under actual test. In this building the best formula for reinforced concrete construction was used. Note Johnson bar, which had been turned up at ends to resist shear strains. The pile of unburnt sacks that are seen indicate that these girders were subjected to very little heat, having been destroyed by action of the quake.

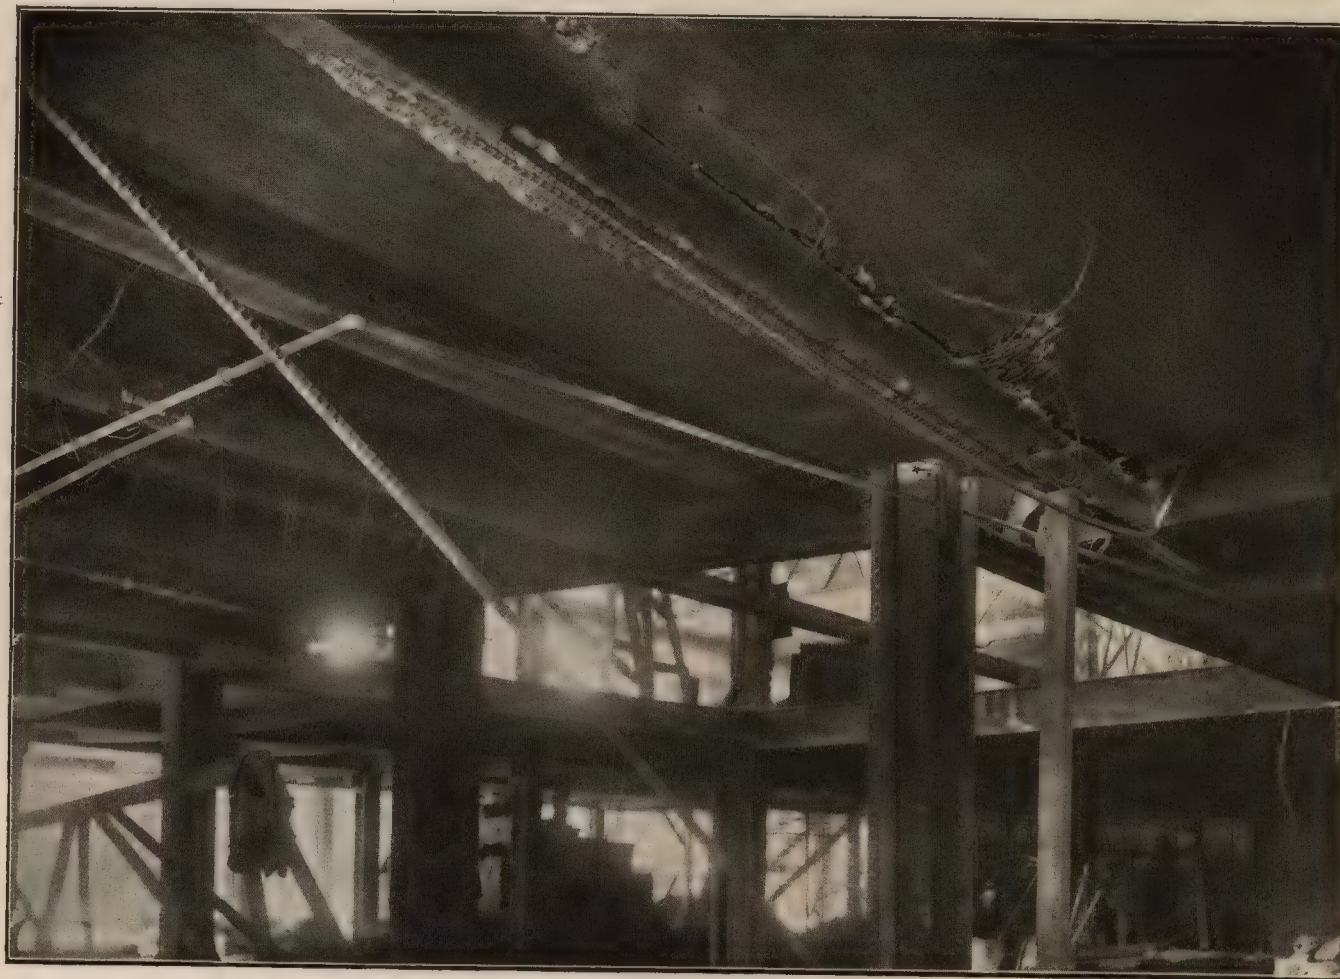
### *Monadnock Building*

Destroyed reinforced concrete girders. The claim of reinforced concrete engineers of the adhesiveness of concrete to steel is here disproved. Note bars which remain straight and unbroken and clean of the concrete.

According to the theoretical teachings these bars embedded in concrete should have sheared or broken.

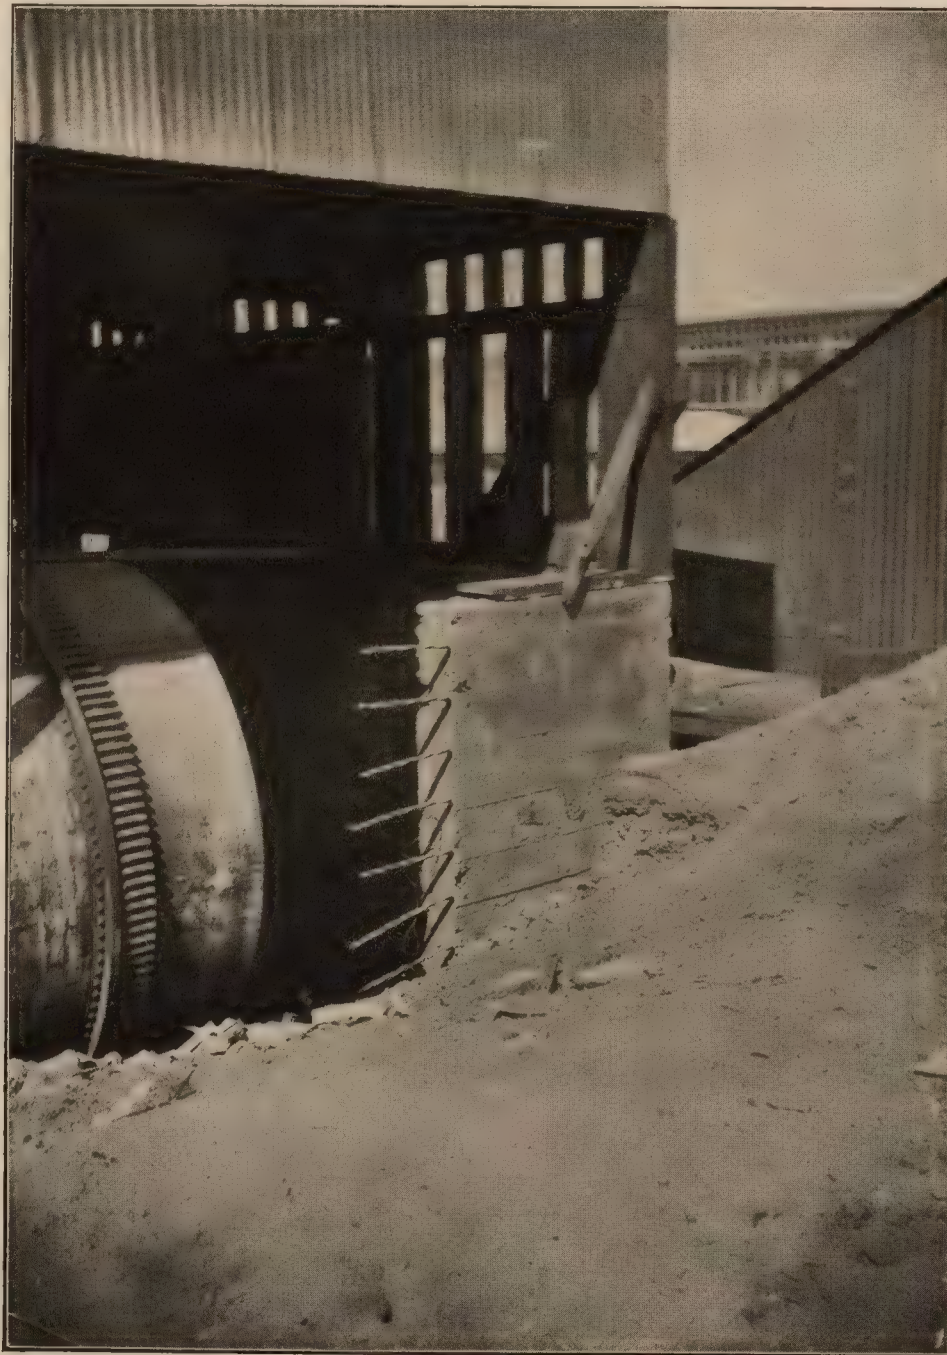
*Reinforced Concrete or Monolithic Construction*

Building on Francisco street, between Stockton and Dupont streets.

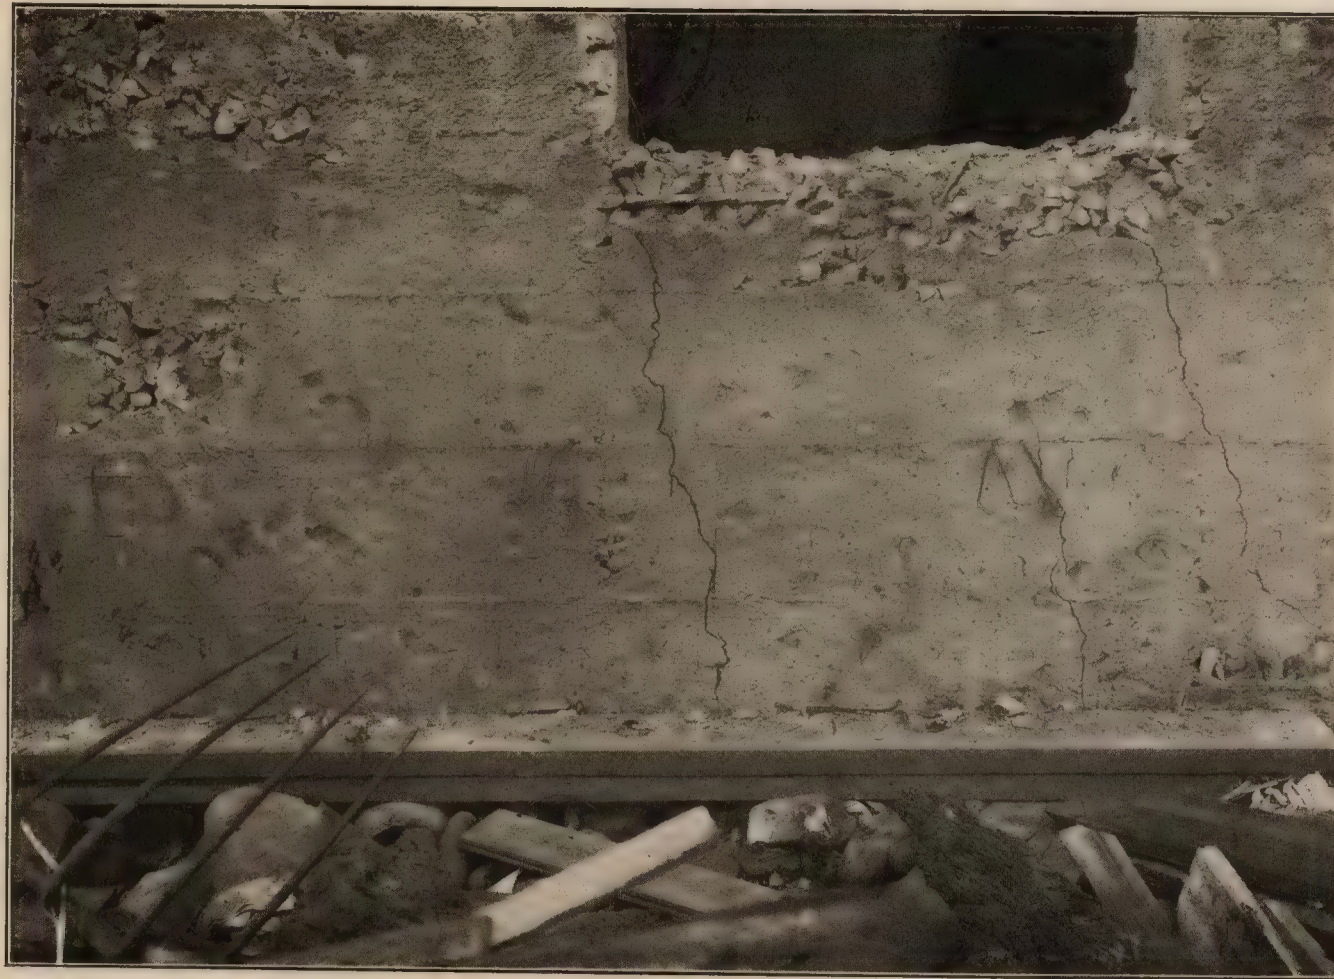
*Showing Side Wall of Same Structure*

The many perpendicular cracks in the wall indicate that concrete and steel do not expand and contract together under heat, steel expanding at a much greater ratio than concrete; therefore cracks appeared. Note disintegrated condition of concrete near opening, caused by fire.

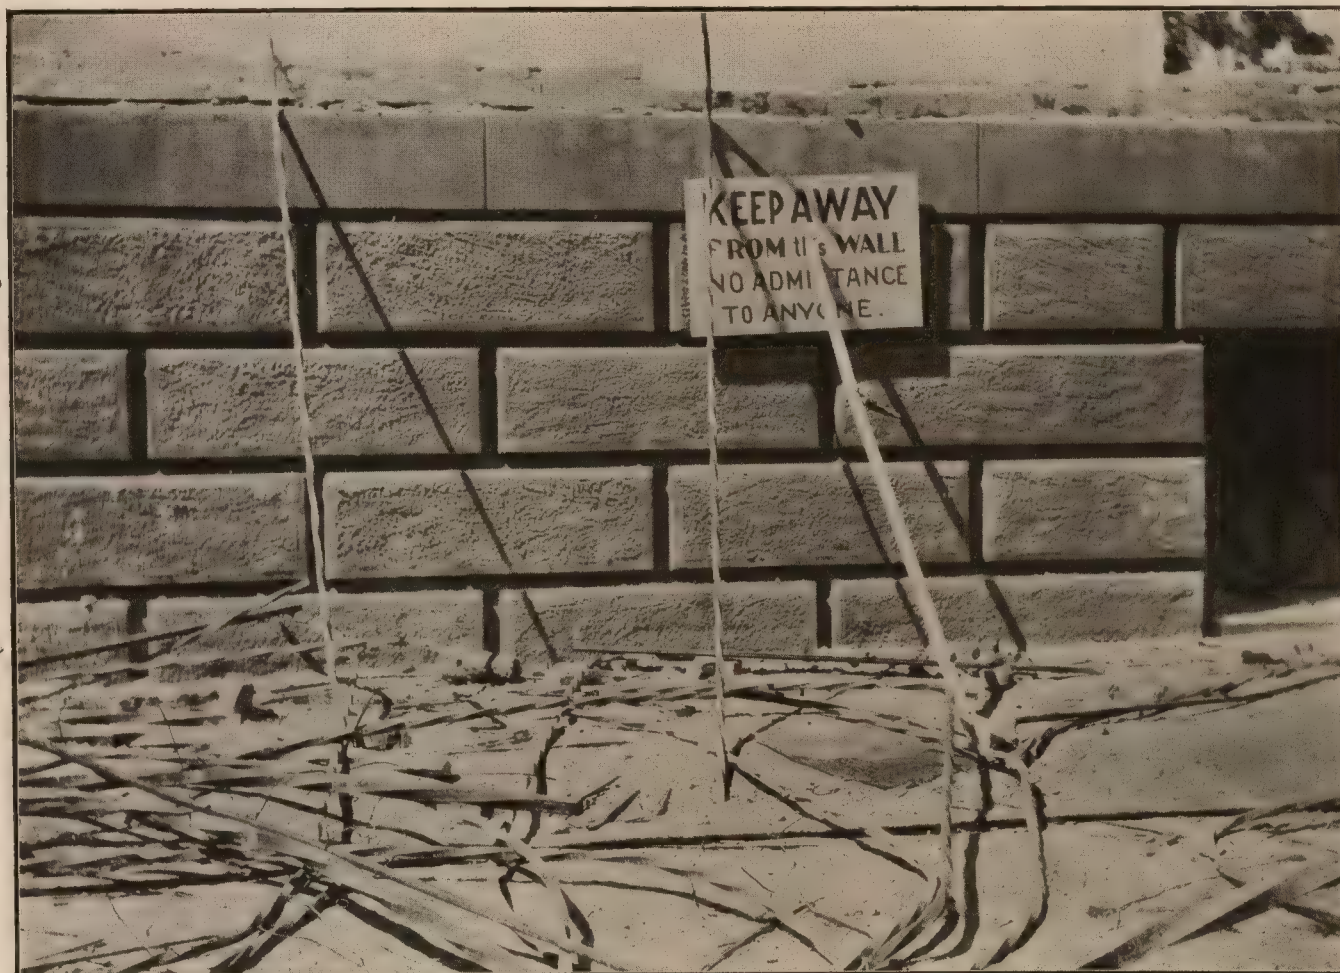
*At Stanford University, Palo Alto. Museum Building*

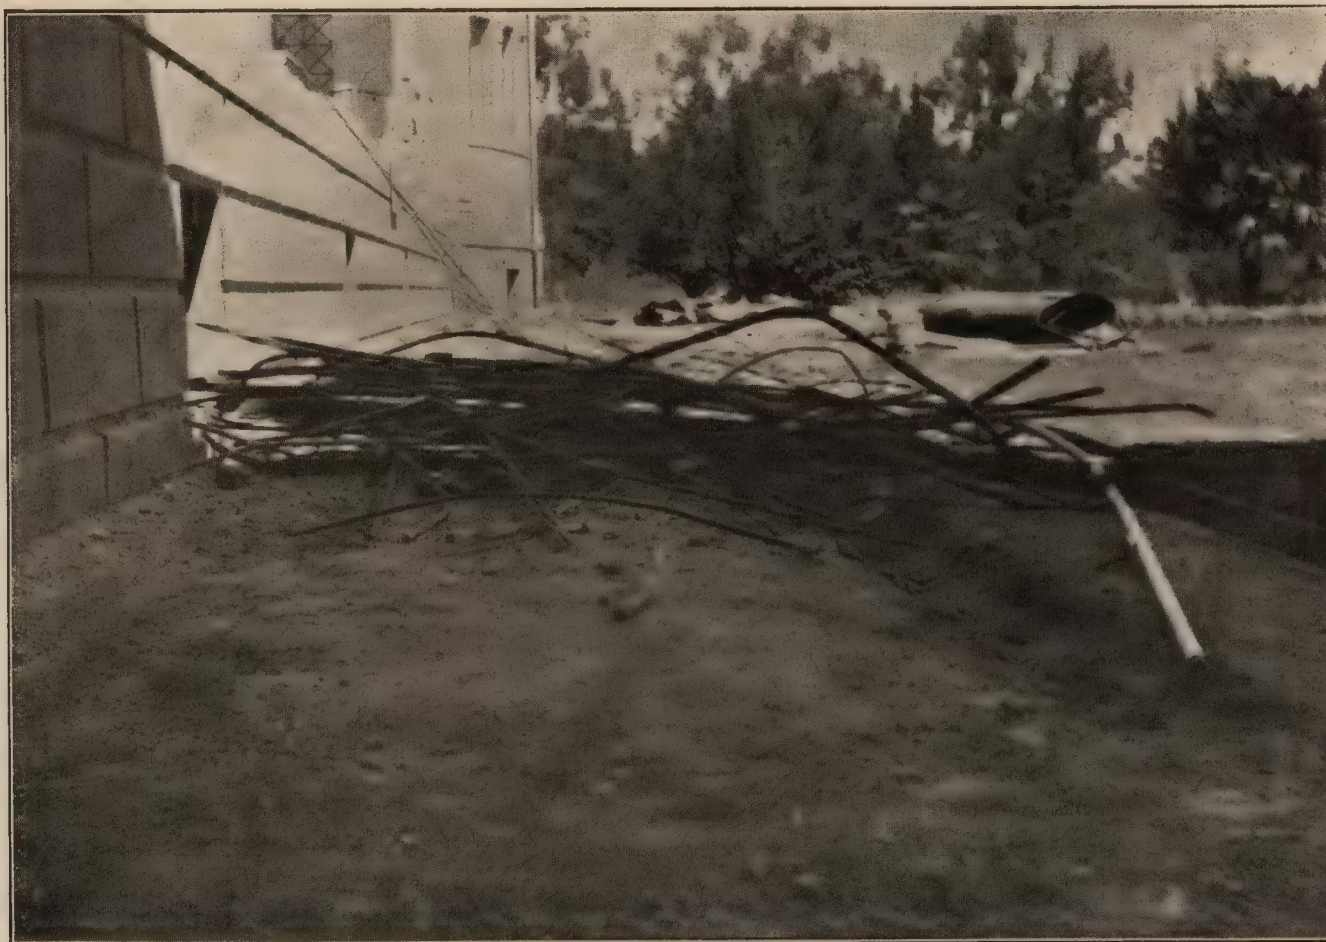
*Twisted Bars*

Pile of reinforcements after collapse at Palo Alto. If there exists any adhesion of concrete to steel bars these bars fail to show it.

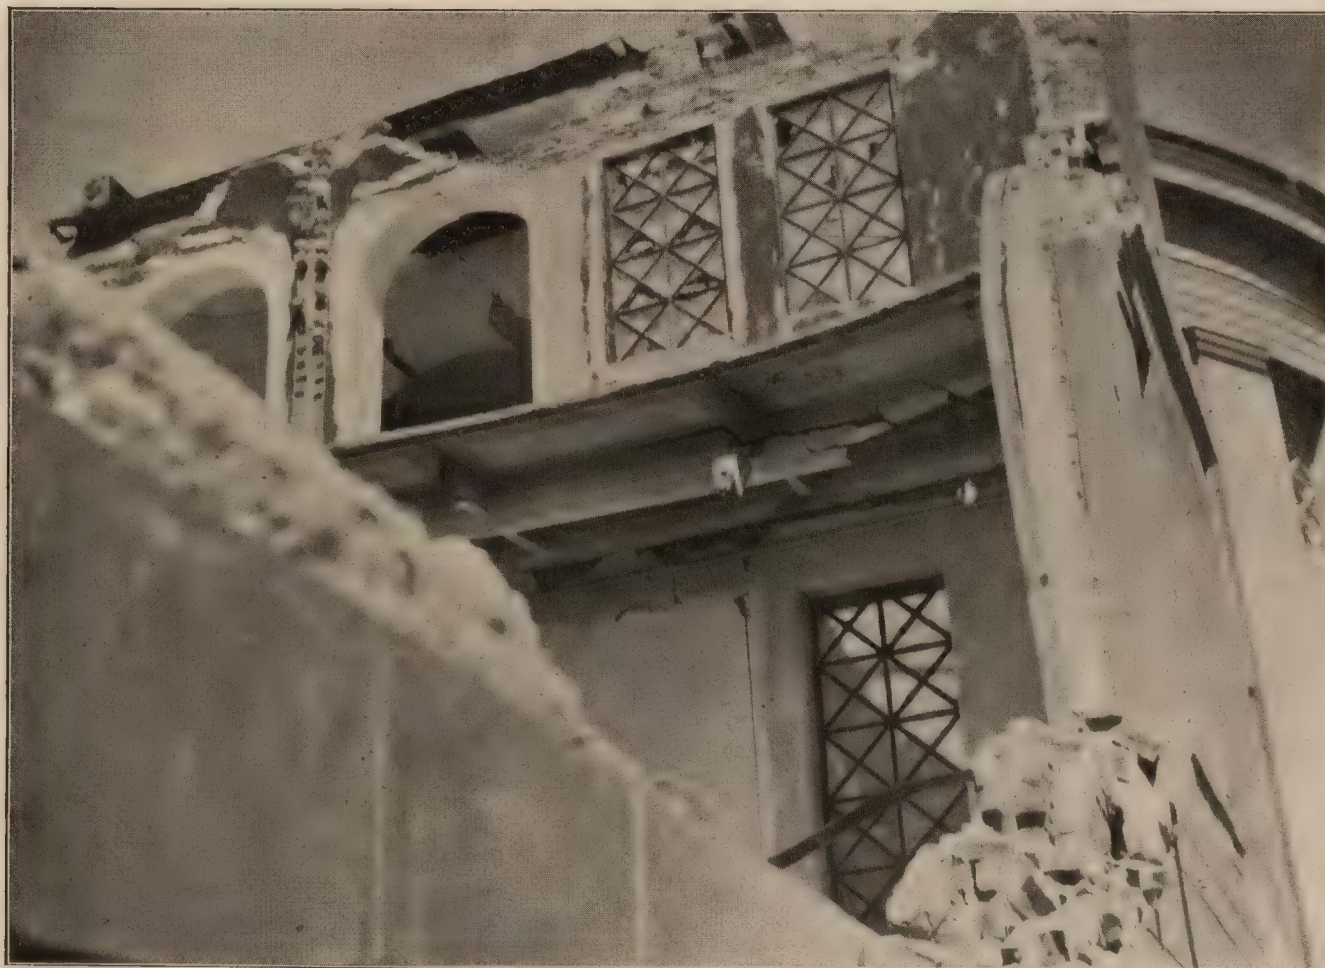
*Interior of Museum Building at Stanford University*

Showing the damage done to brick wall by the collapse of reinforced floor. The wall remains standing, except where floor forced the brick outward. In proof of this note the condition of broken wall, which is bent outwardly by the force from within.

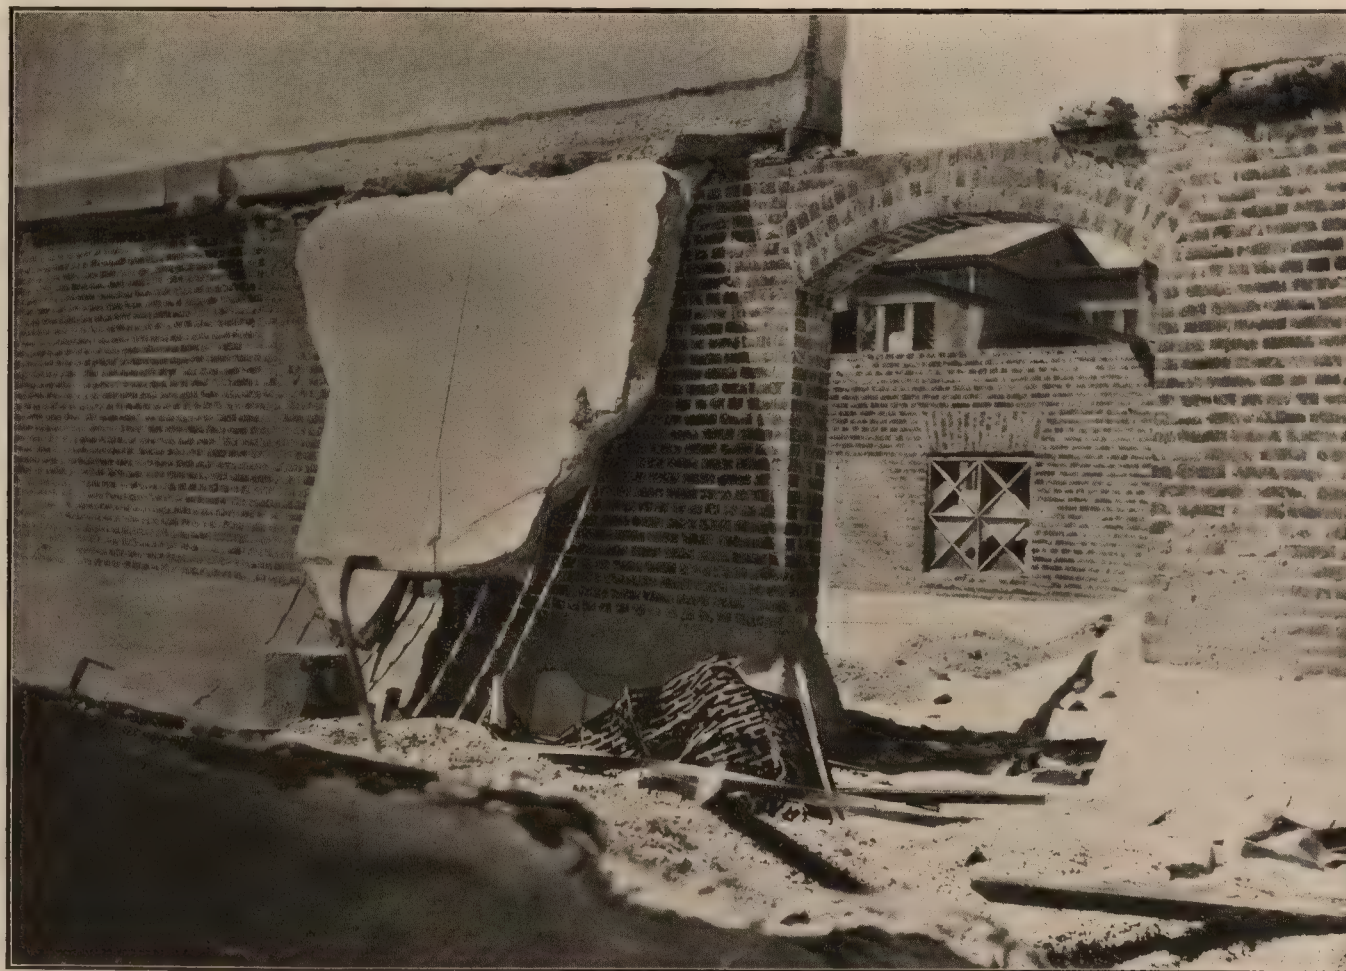
*Interior of Museum Building, Stanford University*

Monolithic floors, Ransome system. Note the perfect condition of brick walls, especially the small brick arch; also the breaking line of the floor.

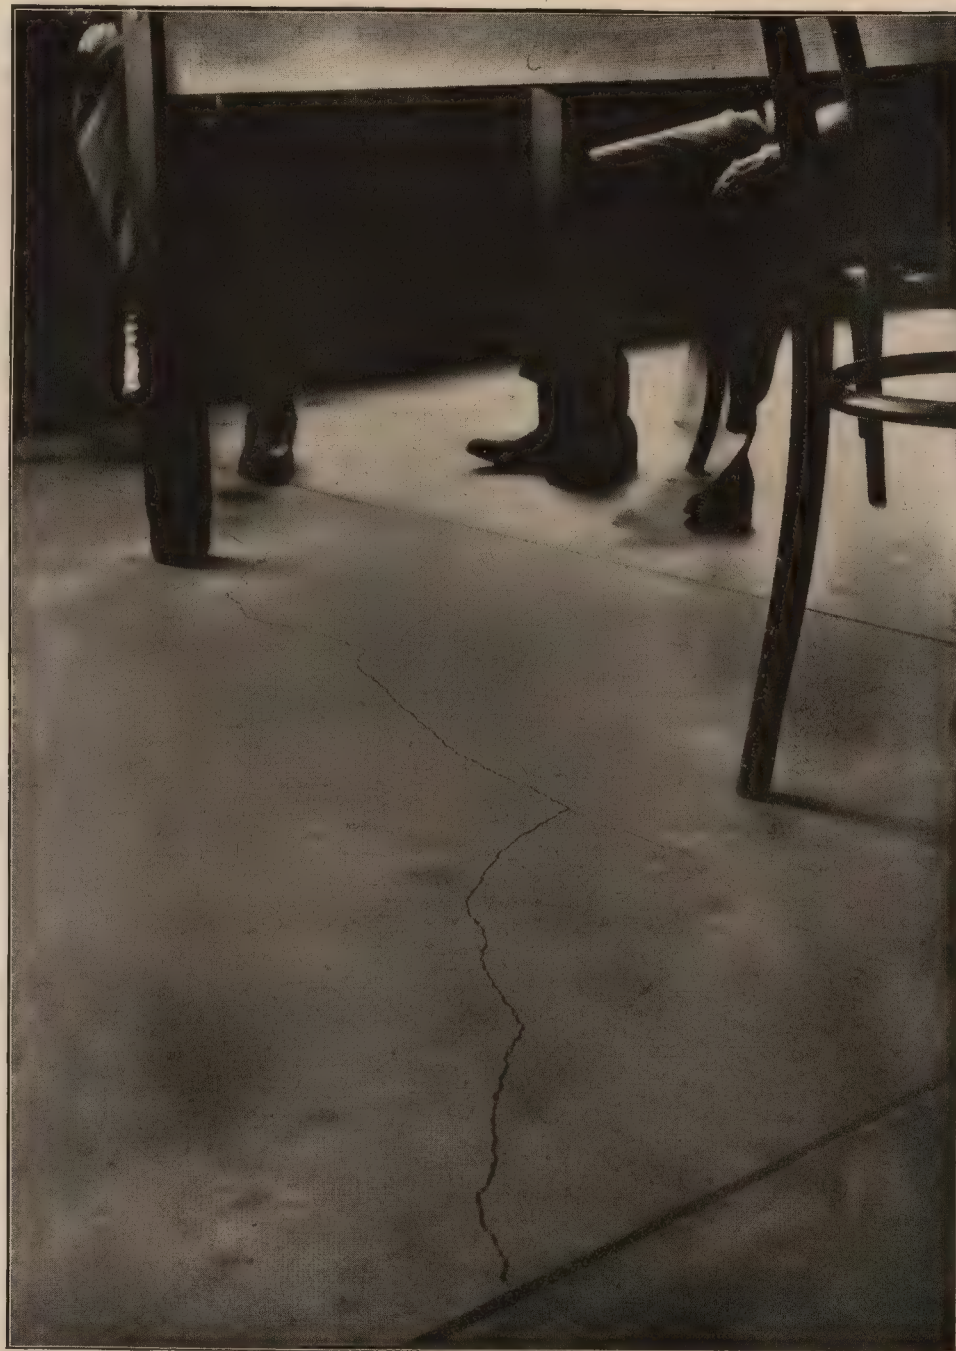
*Reinforced Concrete —Interior  
View, Homer Laughlin  
Building*

ROOF GARDEN SAID TO BE UNSAFE.

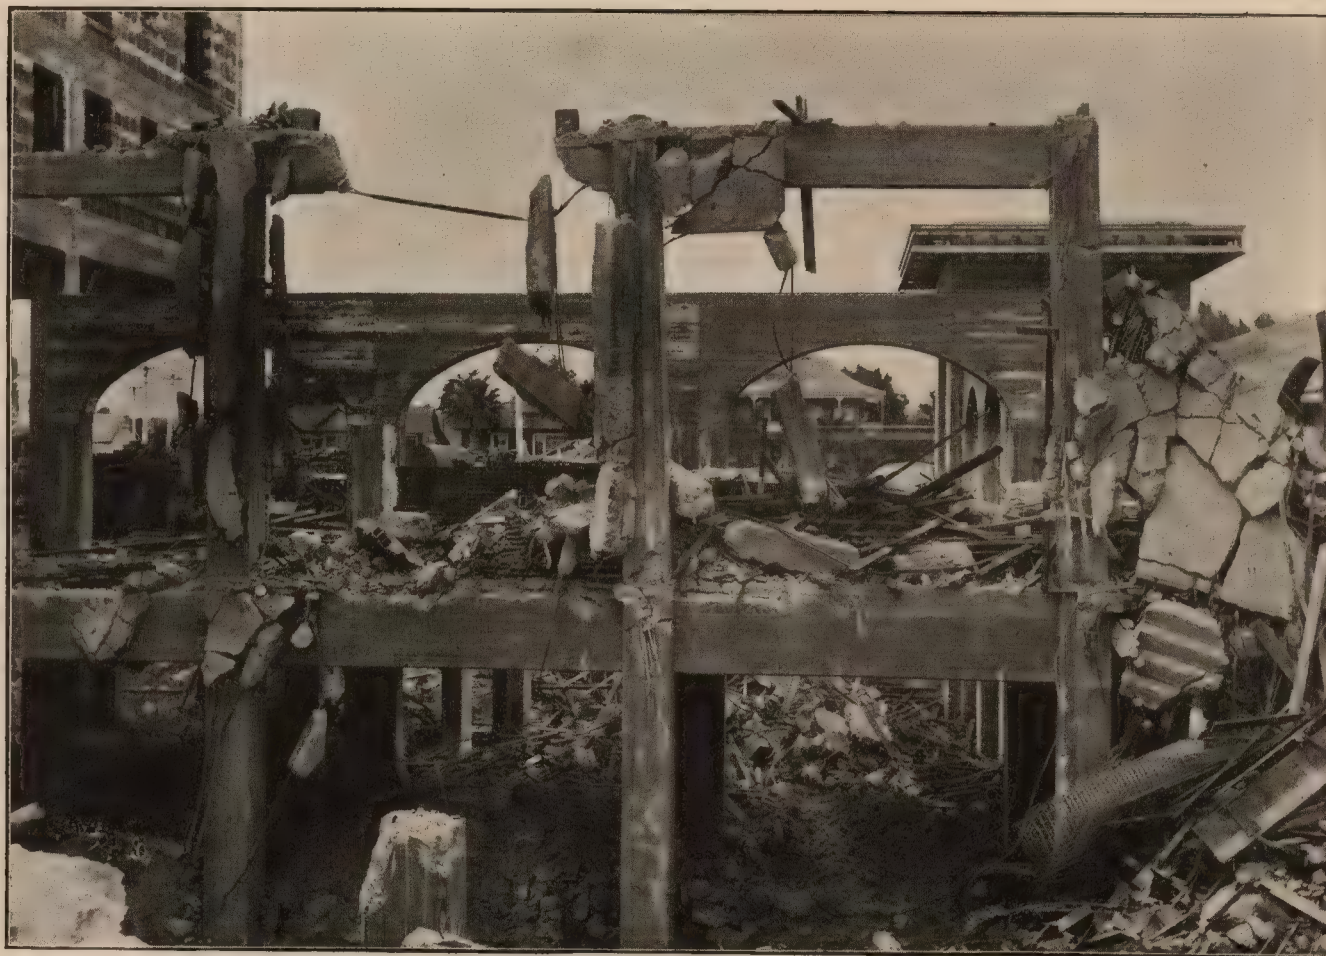
*Collapse of the Bixby Hotel at Long Beach, Cal.*

General view showing fractured columns and  
girders.
